# Manhole Inspection Summary

Manhole # S17A\_\_021MH

Insp Date: **4/16/09 10:54 AM**

**Location** Address: **REAR 2333 LANVALE ST**

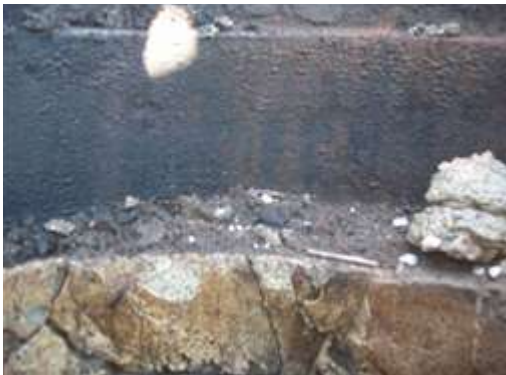
Defect 2

Condition: ☐ Sound ☒ **Cracked** ☐ Root Intrusion ☐ Loose Brick ☐ Deteriorated

CRACKED CORBEL

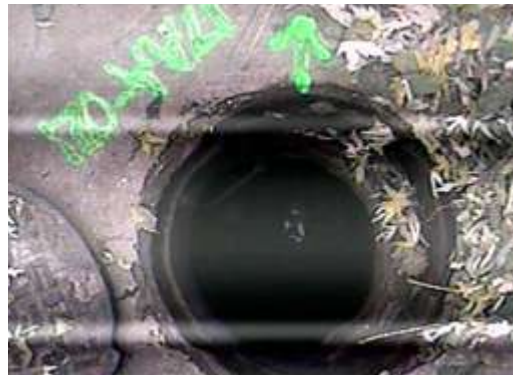
Defect 1

**Frame** Offset: **4** (in.) Condition: ☒ Sound ☐ Cracked ☐ Leaks

FRAME OFFSET

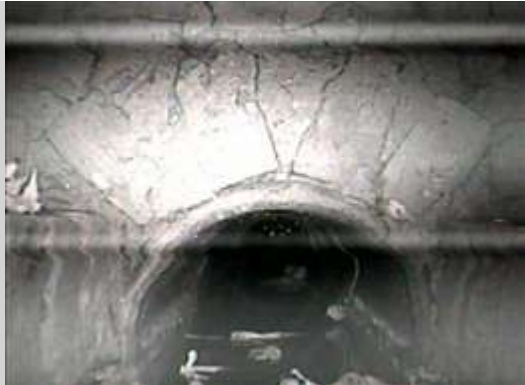
12 O'Clock Outflow

8 in. Circular Gravity Sewer  
Pipe Out @ 12 O'Clock

Invert Depth: **13.84** (ft.) Flow Characteristics: **Slow**

Infiltration: **None** Pipe Seal Cond: **Sound**

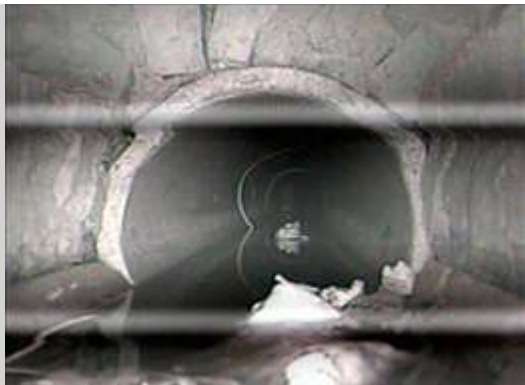
6 O'Clock Inflow

8 in. Circular Gravity Sewer  
Pipe In @ 6 O'Clock

Invert Depth: **13.88** (ft.) Flow Characteristics: **Slow**

Infiltration: **None** Pipe Seal Cond: **Broken**
